Simultaneous monitoring of a collapsing landslide with video cameras

K. Fujisawa and J. Ohara

Public Works Research Institute, Japan

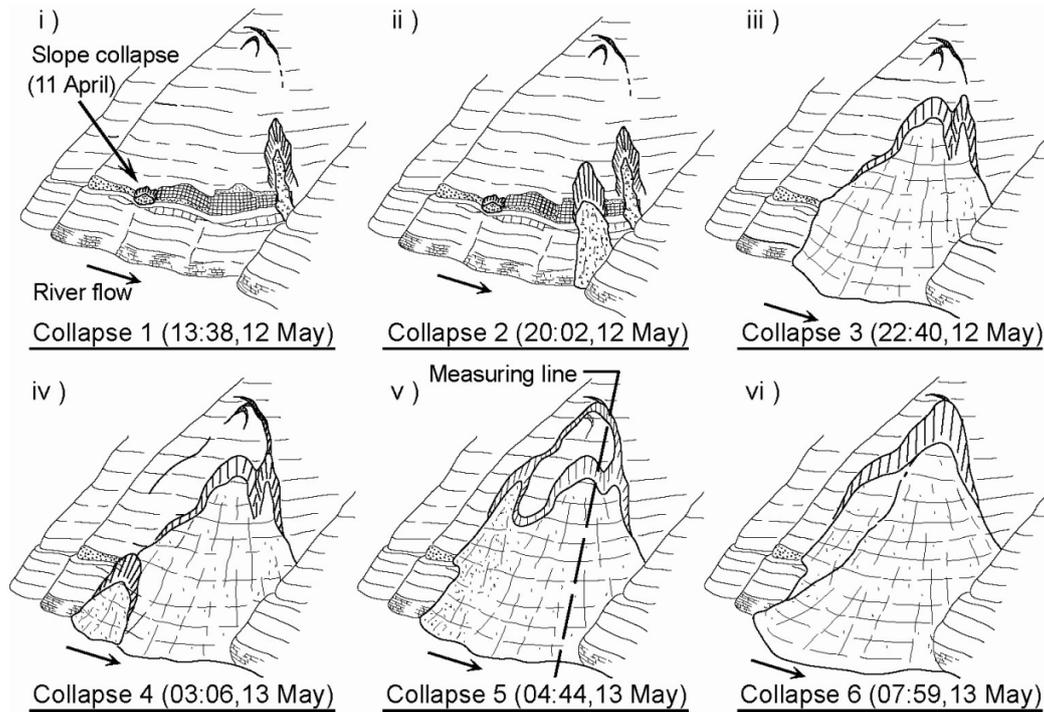
Fig. 2. History of collapses.

The analysis of images before and after the landslide showed that the slope collapse involved debris in excess of 1000 m³, and that six separate landslide events occurred. Figure 2 shows sketches of each landslide event, numbered 1 through 6. Based on analysis of the images, the sequence of events leading to the landslide is thought to be as follows:

1. Slope collapse is confirmed on the slope next to the road on the mountain on 11 April. A major crack is identified at the top of the slope on 21 April. A slope collapse of approx. 2000 m³ (Fig. 2i) occurs near the downstream extension of the crack at 13:38 on 12 May.

2. Several minor falling rock events occur in the region of Collapse 1 followed by a further slope collapse on 11 April. A second slope collapse of around 1000 m³ (Fig. 2ii) occurs at 20:02 on 12 May a short distance upstream of Collapse 1.

3. A steady succession of falling rock and slope collapse events begins at 22:23 on 12 May, in the vicinity of Collapses 1 and 2, leading to a major slope collapse of approximately 10 000 m³ at 22:40 (Fig. 2iii).

4. After a brief hiatus following Collapse 3, the next major slope collapse (Fig. 2iv, estimated at 1000 m³) occurs at 03:06 on 13 May near the foot of the slope on the upstream side. Due to the camera angle and poor visibility at night, the images provide only limited detail, although evidence of localized tree shaking suggests that the crack at the head of the landslide was beginning to extend upstream of the slope.

5. A further slope collapse (Fig. 2v, 1000 m³) occurs at 04:44 on 13 May on the slope further up the slope from Collapse 4.
6. Falling rock and slope collapse events begin at approximately 07:40 on 13 May on the middle and lower part of the slope and become more frequent, culminating in a major slope collapse (Fig. 2vi, 40 000 m³) at 07:59. This is followed by more falling rocks and minor collapses, but without any further significant topographical

Thus, the sequence of events leading up to the landslide began with collapses at the periphery of the landslide area (from the head to the sides and toe), where the effect of stress caused by movement is most apparent, followed by an increasing incidence of falling rocks and minor collapses in the area.

Judging from the analysis of the landslide images of Collapses 1 and 2 (Fig. 2), the first collapses that were the precursors of the landslide occurred mainly at the top of the grating crib works on the mountain side of the road, and the collapse phenomenon just before the sliding of Collapse 6 also occurred mainly at the top of the grating crib works. Thus, it

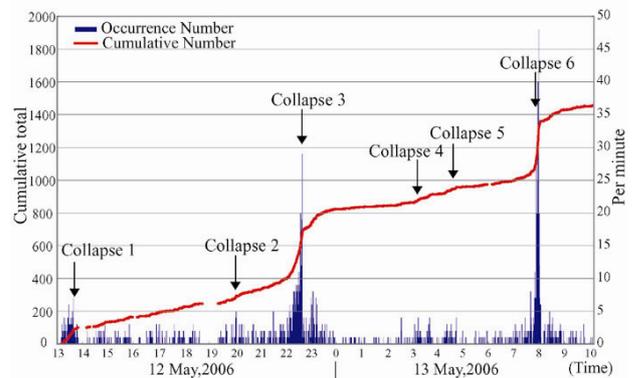
Fig. 3. Other events – falling rocks, slope collapses and fallen trees.

Figure 3 shows the count of falling rock events, slope collapses and fallen trees. Prior to the six major collapses, the frequency of these events steadily increased. The rate of increase was particularly pronounced prior to the two largest collapses (numbers 3 and 6).

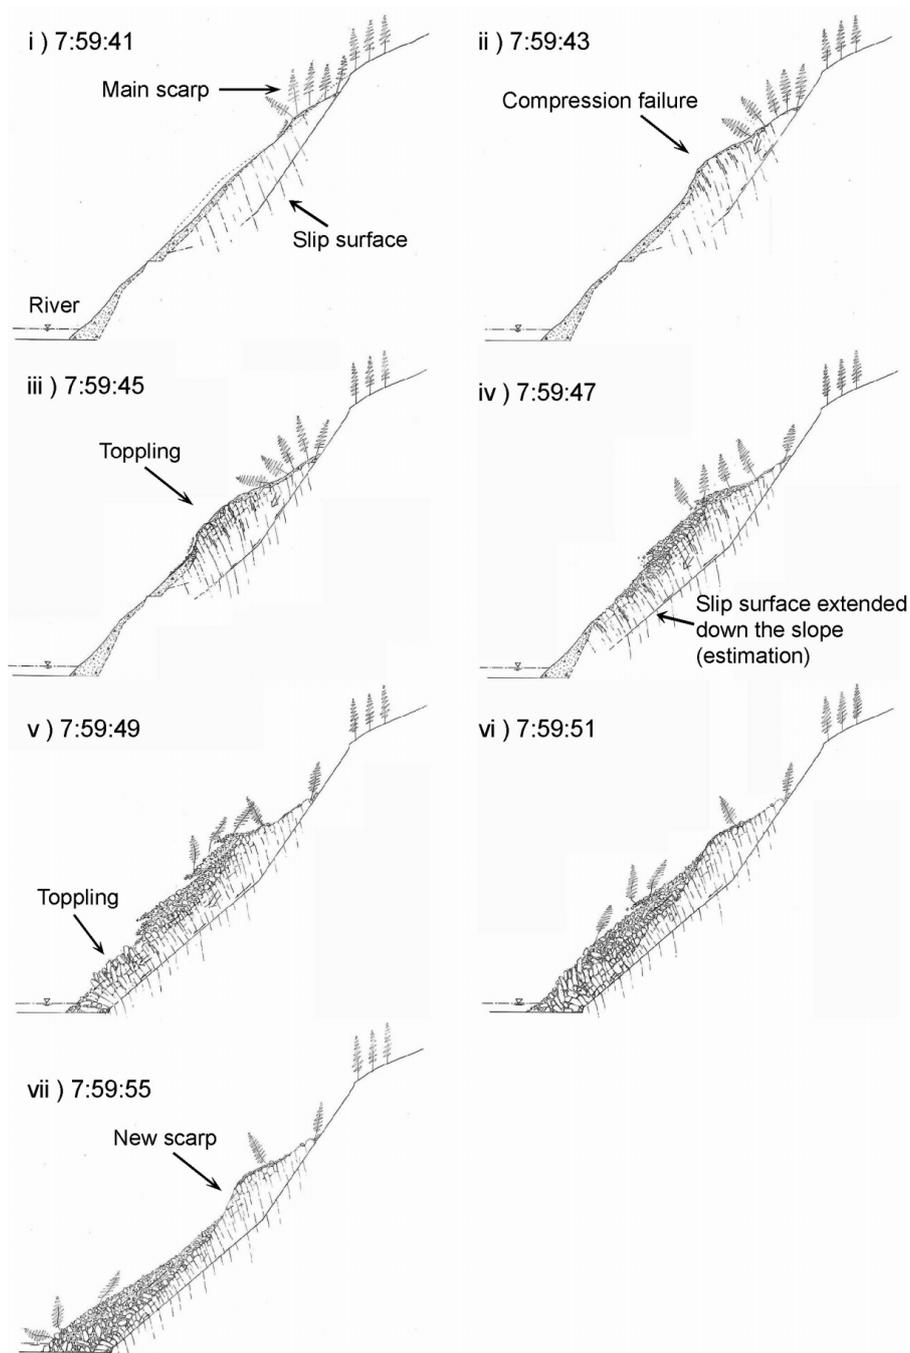
Fig. 4. History of collapses during sliding of Collapse 6 (occurring at 7:59 a.m. on 13 May).

Figure 4 shows the results of sketches made for about 20 s during the movement of Collapse 6 shown in Fig. 2 (occurring at 7:59 a.m. on 13 May), the largest slide that occurred while the landslide moved.

As shown in Fig. 4, the section diagrams were estimated based on several images taken from some different angles representing the 20 s from 07:59:35 to 07:59:55 on 13 May. These section diagrams were prepared along the measuring line shown in Fig. 2v. These were used to study the state of change of the moving soil mass accompanying the movement of the landslide.

The results showed that cracks formed in the landslide body located below the main scarp at the time of Collapse 5, and the collapse expanded from that location. When the landslide started to move, many collapses began to occur along the edges of the landslide (head – side/toe) (Fig. 4i). The movement of the landslide is thus assumed to be accompanied by a toppling movement (Fig. 4ii–iii). Afterwards, the head to the middle of the landslide body was crushed, resulting in the formation of debris deposit. (Fig. 4iv) As this debris deposit covered the entire lower part of the slope, the toppling was confirmed at the toe of the landslide (Fig. 4v–vi). It is presumed that the toppling occurred at the toe of the

landslide because the stress produced by the movement of the landslide reached the lower part of the slope. The landslide body remained near the top of the slope; however, because the collapse flowed downward with the toppling, a new scarp was formed near the center of the slope (Fig. 4vii).

can be assumed that, until just before Collapse 6, the toe end of the landslide was located slightly above the road. But on the downstream side of the landslide, it was confirmed that the toppling phenomenon that occurred from the head to the middle part of the landslide spread to the toe of the landslide. Therefore, the stress produced by the movement of the landslide in Collapse 6 reached the lower part of the slope, expanding the slip surface downstream to the road.

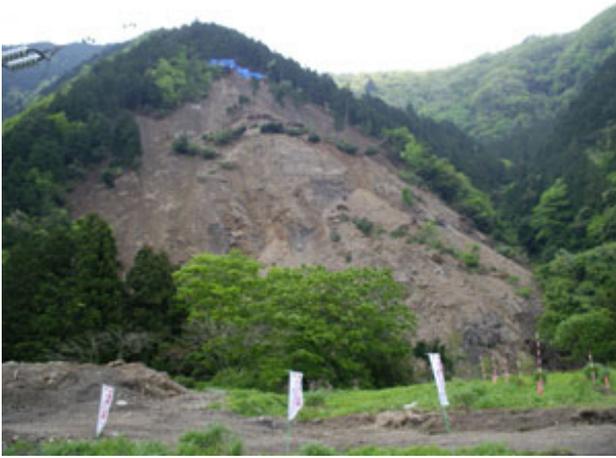
Fig. 5. General view of the landslide site (14 May 2006).

approximately 150 m in width by 135 m in height, with a volume of approximately 250 000 m³ (Fig. 5).

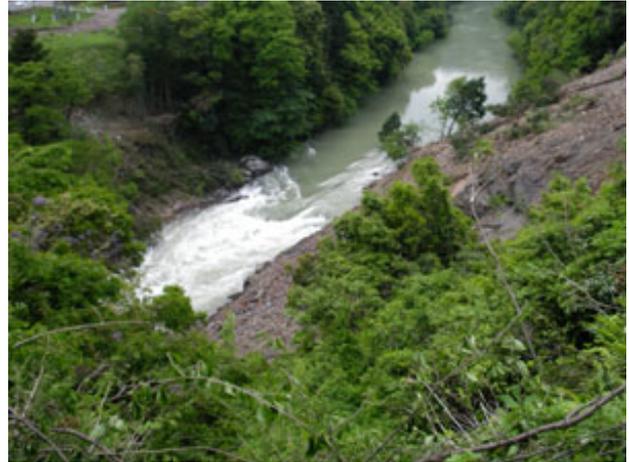
Fig. 6. Debris deposits in the river course (14 May 2006).

Image analysis, together with field measurements using a ground-based laser scanner after the collapse, indicated that the landslide produced a total of 50 000 m³ of debris. It flowed into the river during the landslide. As Fig. 6 shows, this blocked some two-thirds of the width of the river, and also caused damage to several local roads, but most of the landslide body remained on the affected slope.
